Contract #: 04-0120F4Cty: SF/ALA Rte: 80 PM: 13.2/13.9File #: 69.28**WELDING INSPECTION REPORT****Resident Engineer:** Pursell, Gary**Address:** 333 Burma Road**City:** Oakland, CA 94607**Report No:** WIR-003881**Date Inspected:** 25-Aug-2008**Project Name:** SAS Superstructure**OSM Arrival Time:** 700**Prime Contractor:** American Bridge/Fluor Enterprises, a JV**OSM Departure Time:** 1500**Contractor:** Zhenhua Port Machinery Company, Ltd (ZPMC), Changxing Island **Location:** Shanghai, China

Bridge No: 34-0006**Component:** bottom plates, edge plates, side panels**Summary of Items Observed:****Sub-assembly - Bay 3**

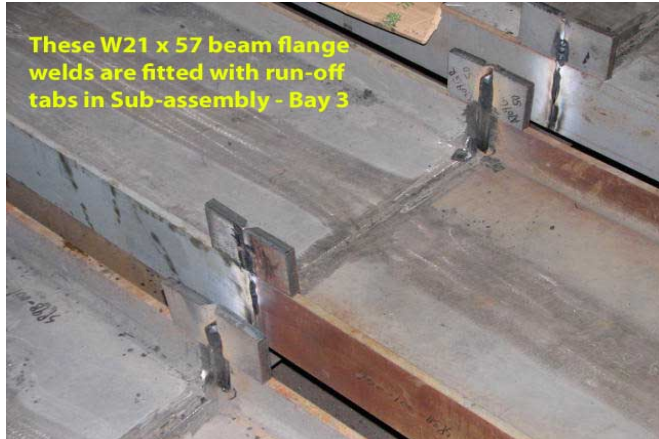
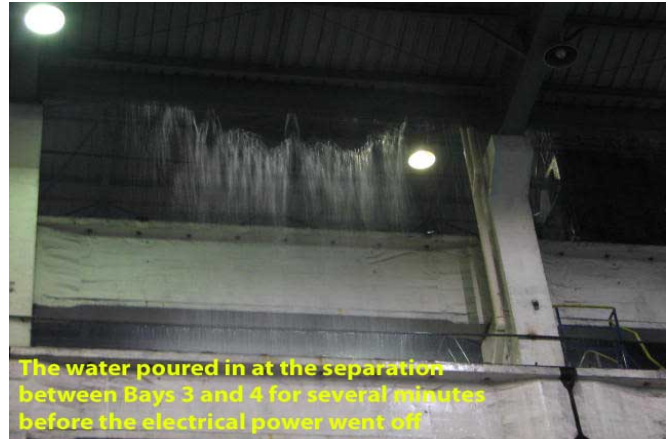
At 0915 hours, QA Inspector entered this bay and observed rain water pouring in from the roof in solid sheets at the separation between Bays 4 and 5. All work appeared to be stopped, at least temporarily. Then at 0925 QA Inspector observed rain water pouring in from the roof in solid sheets at the separation between Bays 3 and 4. At 0936 hours the electrical power in the entire Bays 3, 4, and 5 failed. All lighting was out and no welding or other work was being performed. The power remained off during the entire day shift. Present in this bay were ZPMC CWI's Shazhi and Yu Dong Ping as well as ABF QC Larry Luo, although no welding work was observed by QA Inspector.
